**No Further Accelerated  
Action Justification  
for the Sanitary Sewer System,  
PAC 000-500**

**March 2005**

**NO FURTHER ACCELERATED ACTION JUSTIFICATION  
FOR THE SANITARY SEWER SYSTEM  
PAC REFERENCE NUMBER: 000-500**

**CLOSURE STRATEGY FOR THE ROCKY FLATS ENVIRONMENTAL  
TECHNOLOGY SITE**

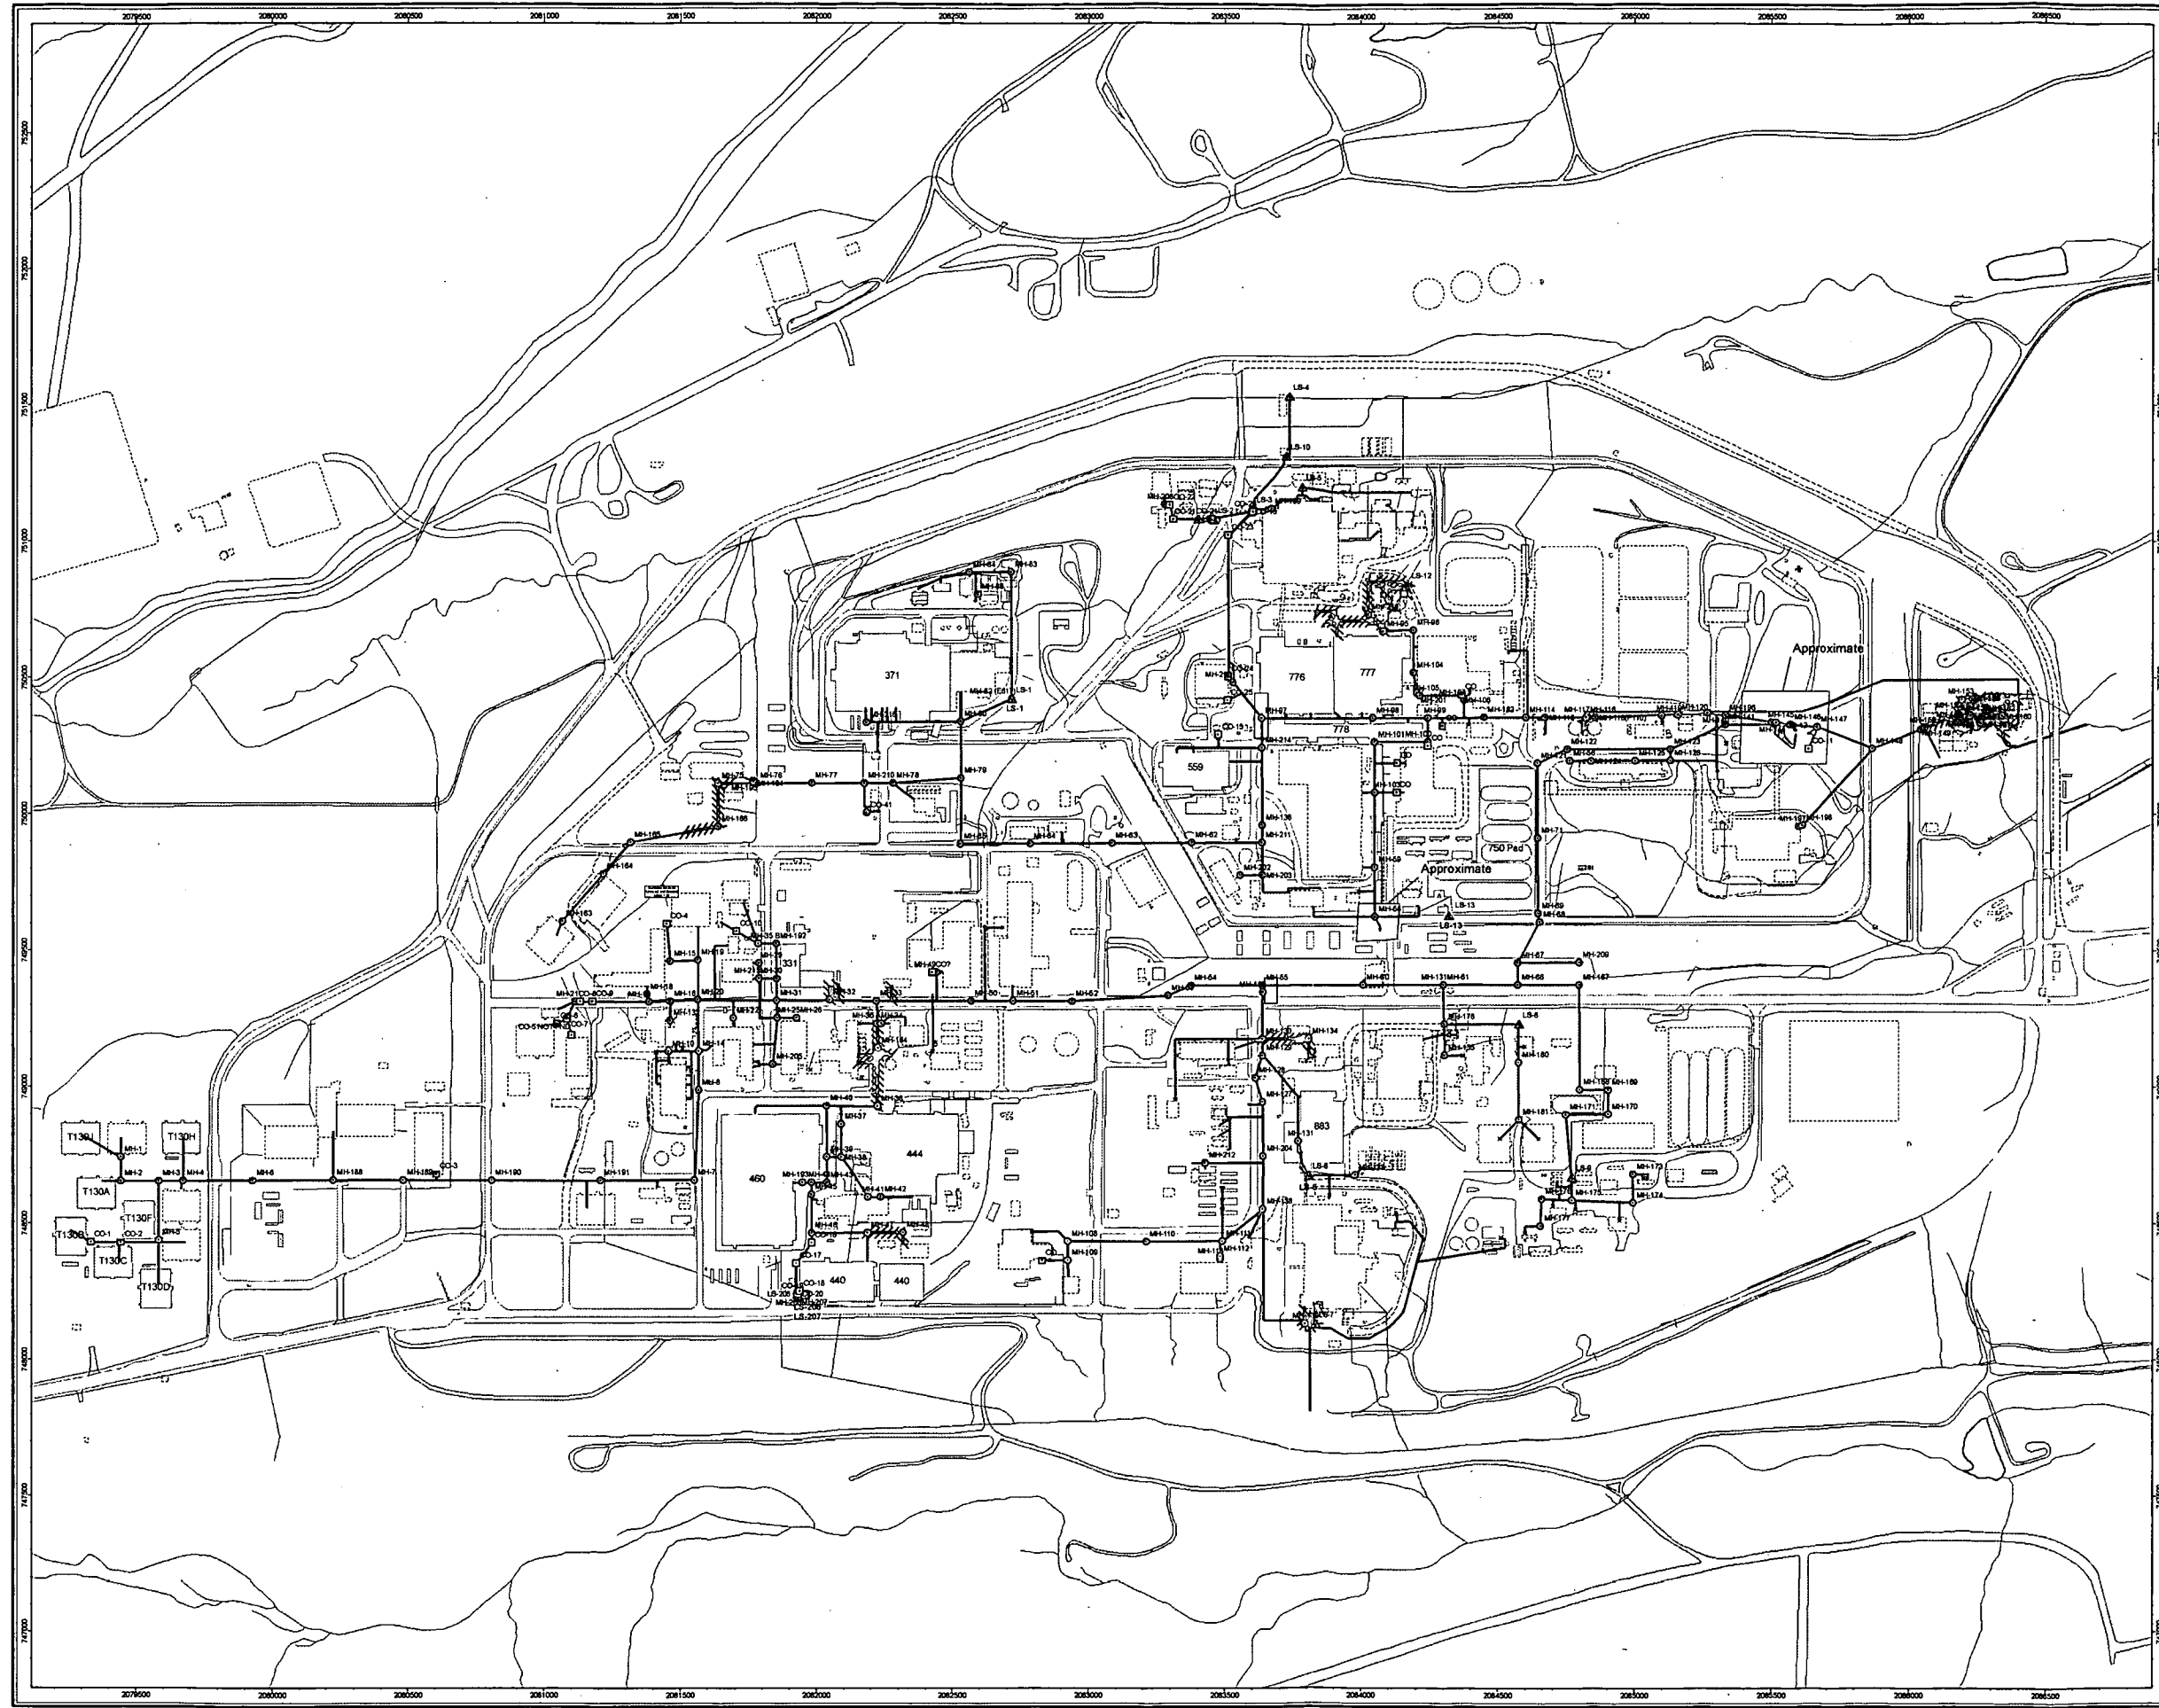
**Figure 2**  
**Sanitary Sewer System**  
**At Closure As of 2/24/05**

Prior to closure, the estimated total length of the sanitary sewer lines was approximately 67,000 feet including active and abandoned lines. The diameter of the lines ranged from 3 to 12 inches with approximately 30,000 feet of 6-inch and larger lines and approximately 11,500 feet of 4-inch lines. The lines included vitrified clay pipe (VCP), as well as polyvinyl chloride (PVC) pipe, cast iron, and ductile iron pipe. PVC lines were installed in 1984 or later. In 1985, portions of the system were rehabilitated to reduce infiltration and leakage. Figure 2 depicts the sanitary sewer system and its components in 2004 (DOE 2004a).

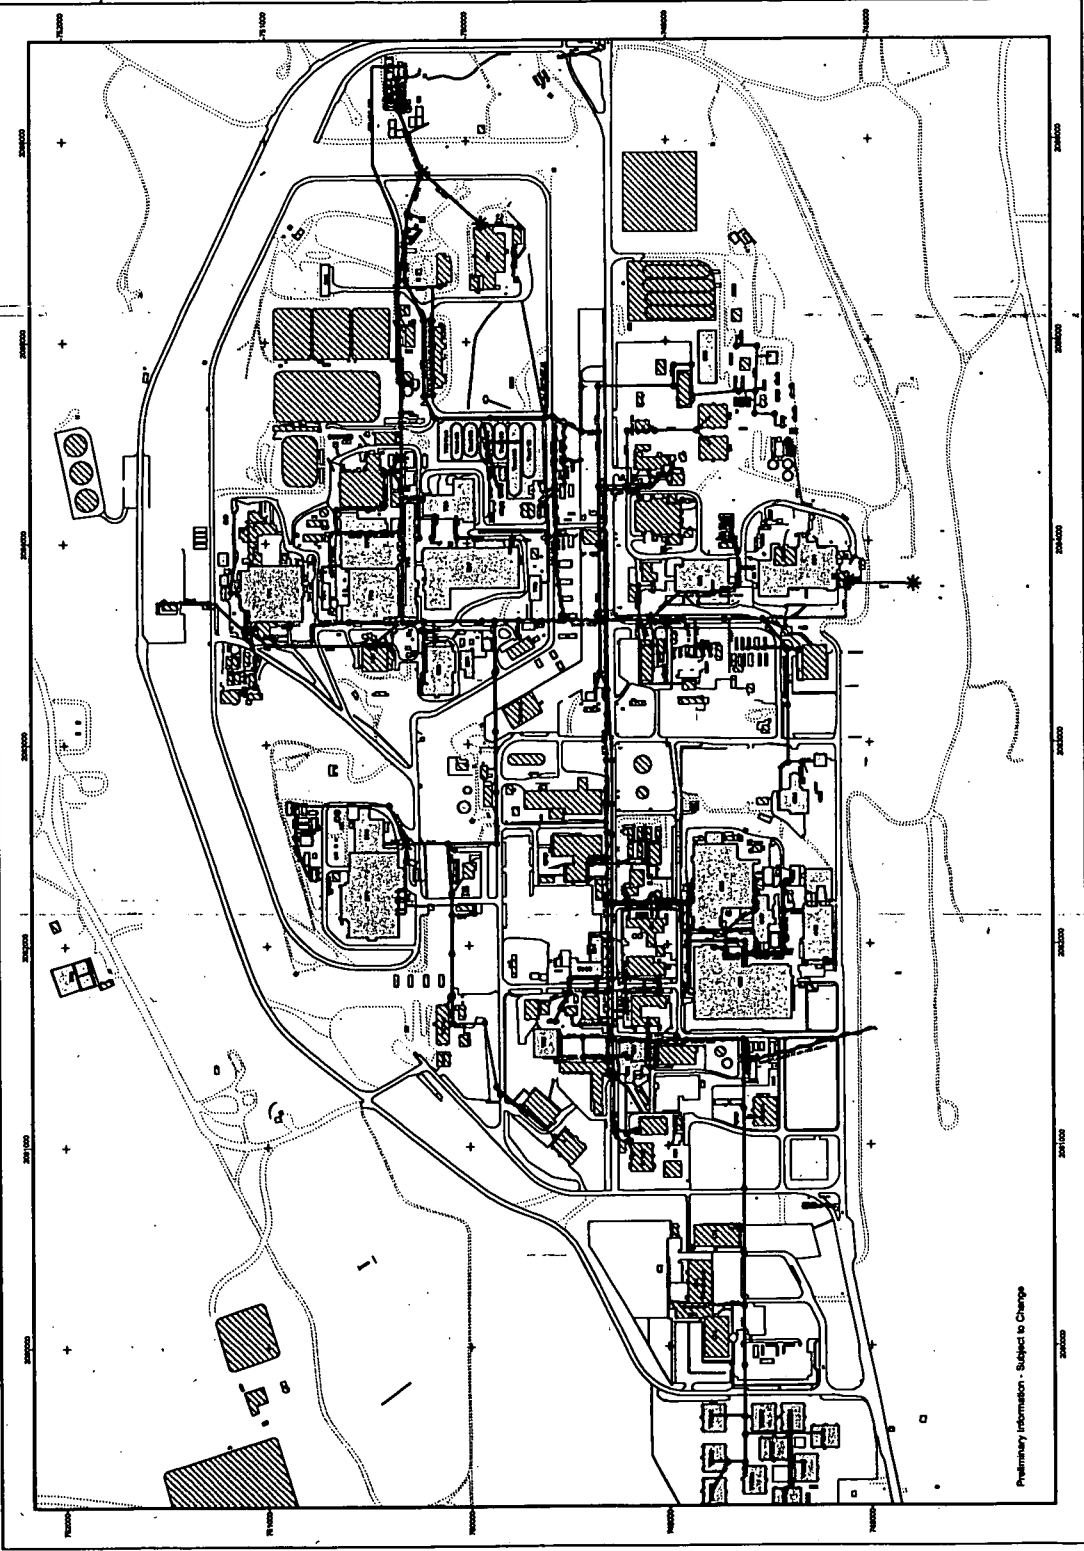
Installation of the sanitary sewer system and associated treatment plant began around 1952 (DOE, 1992). The estimated total length of the sanitary sewer lines is approximately 67,000 feet including active and abandoned lines. The diameter of the lines ranges from 3 to 12 inches with about 30,000 feet of 6-inch and larger lines and about 11,500 feet of 4-inch lines (DOE, 2002b). The lines include vitrified clay pipe (VCP), polyvinyl chloride pipe (PVC), cast iron and ductile iron pipe. PVC lines were installed in 1984 or later. In 1985, some of the system was rehabilitated to reduce infiltration and leakage (Advanced Sciences, Inc [ASI], 1991). The sanitary sewer system is shown in Figure 1.

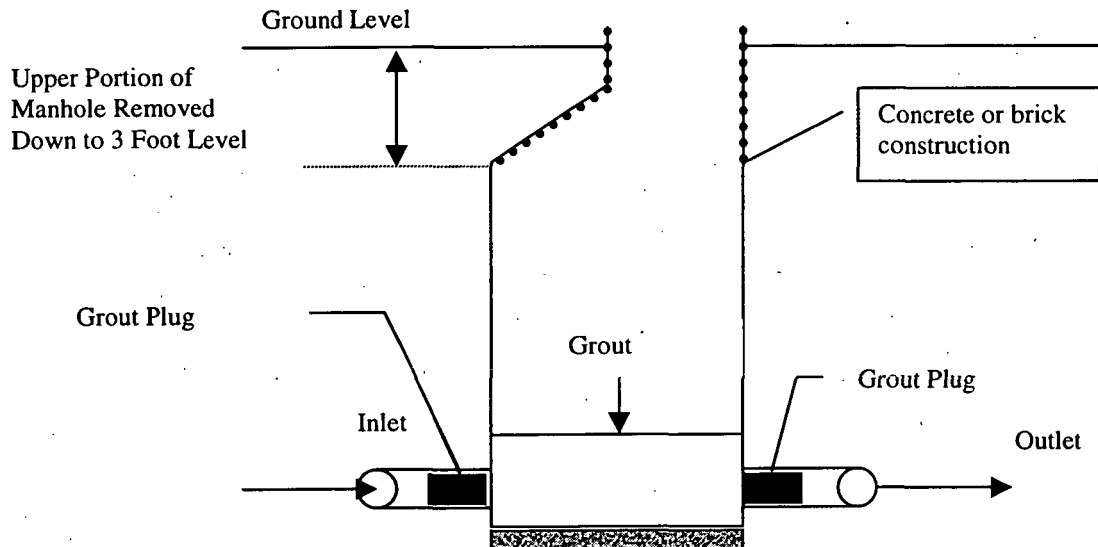
**Figure 2 Best Management Practices at Manholes**

### Typical Manhole

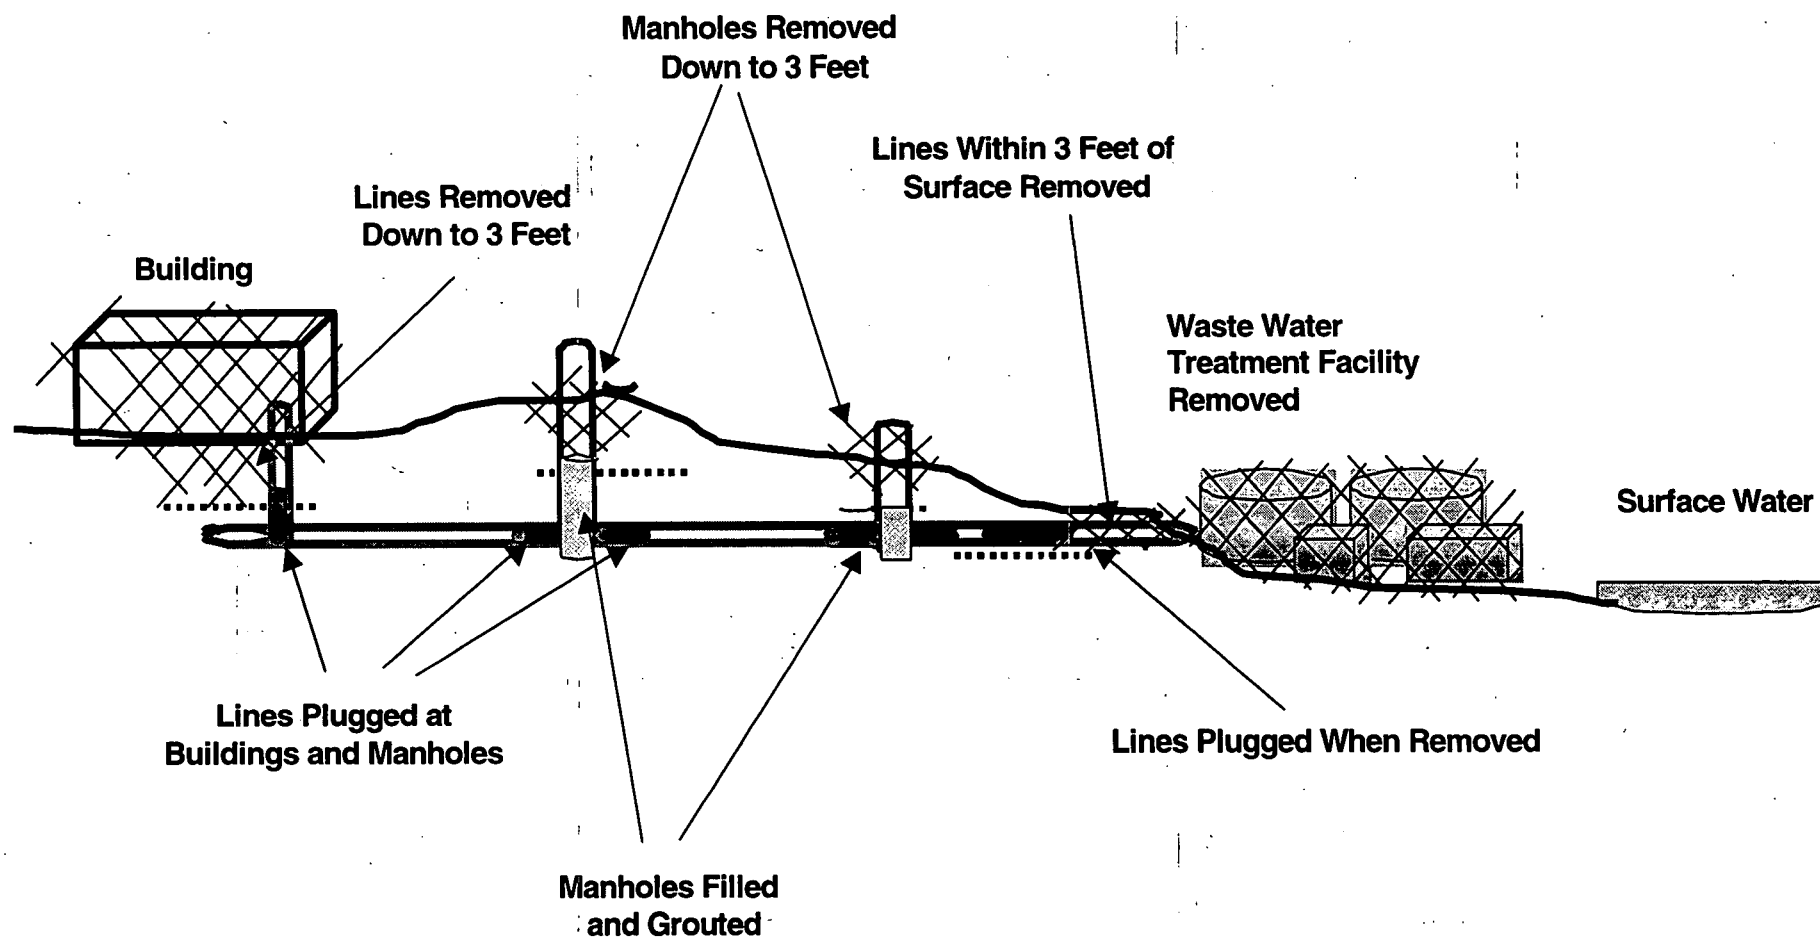
Figure 3 Impediments to Flow in Sanitary Sewer System

Disruption will consist of either excavating the main utility trench, removing the existing sanitary sewers and other associated utilities, and backfilling the excavation with more impermeable material, or grouting or similarly reducing the permeability of the subsurface material. Specific details on how this will be accomplished will be determined during project planning, and not as part of this document.
